WALLKILL RIVER BASIN
ROCK ISLAND LAKE, SUSSEX COUNTY
NEW JERSEY

ROCK ISLAND LAKE DAM NJ 00819

PHASE 1 INSPECTION REPORT
NATIONAL DAM SAFETY PROGRAM

AUGUST 1981

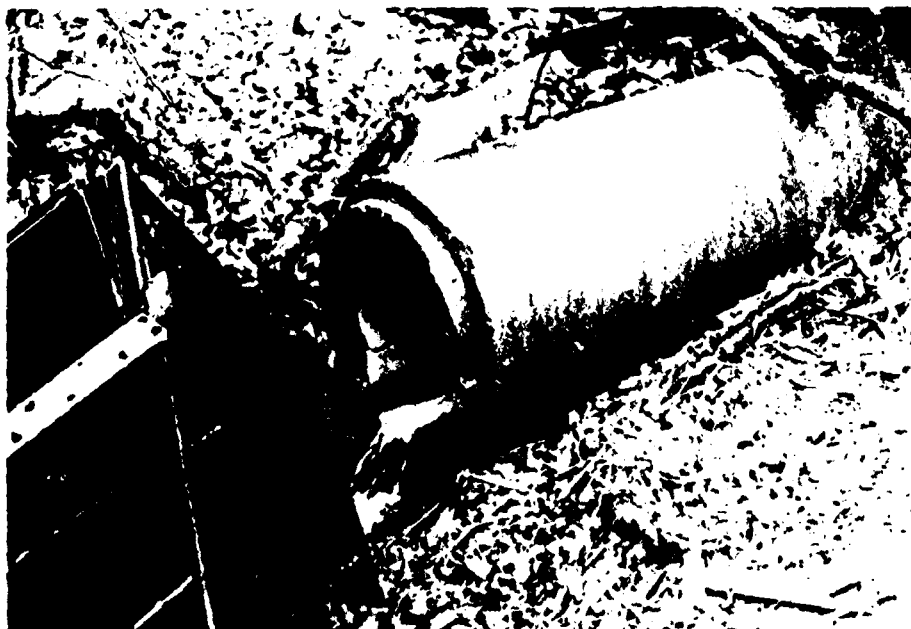
c. Visual Inspection. The inlet box for the spillway pipes contain debris and sediment. The downstream outlet is a 24-inch RCP. At that time, this pipe was discharging a small quantity of whitish-colored, foul-smelling effluent. This may be caused by infiltration through the pipe joints of leachate from dumped material on the downstream face of the dam.

Outlet at center of dam - 24-inch reinforced concrete pipe. Discharging liquid smelling of chemicals. Maybe infiltrating through joints. Ground and rocks around discharge end are discolored and malodorous.

Close-up view of 24-inch RCP spillway outlet pipe

(1) Evaluate the leakage into the spillway discharge pipe and design and oversee corrective measures as required.
